**RE:** *Milestone Structural Inspection (Phase 1)*  
**Subject:** *14701 Cumberland Dr., Delray Beach FL 33446 (Building A)*  
**Folio:** *See Attached List*

## STRUCTURAL SAFETY INSPECTION REPORT FORM

b. Street Address: 14701 Cumberland Dr., Delray Beach FL 33446. (Building A).

i. General Description: 4-story reinforced concrete w/ post-tensioned floors & roof decks. Condo building.

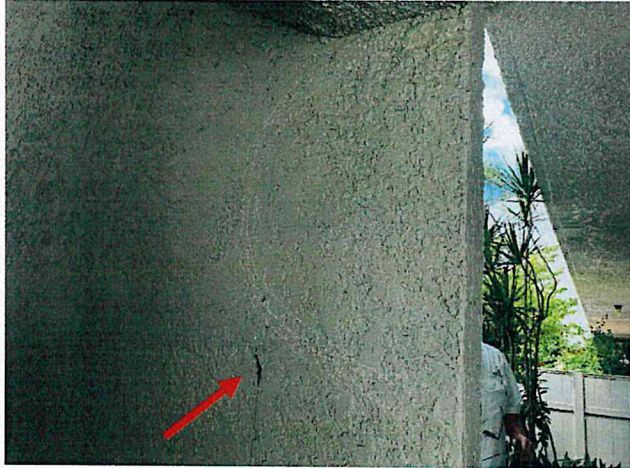
- **2-C – CONDITIONS:**

First, stucco at stairwells shows water entering space between stucco and concrete structural members and traveling downward and leaking out through lower elevation locations out from small cracks in stucco. some delamination of stucco noted. Moreover, at building trash-bin closet at pedestrian door header noticable delamination of stucco is noted. Furthermore, at multiple locations, at front walkway pavers, a number of dislodged pavers resting upon walkway surface are not secured and at risk of falling off walkway to ground level, at hazardous risk to pedestrians below.

STUCCO AT STAIRWELLS SHOWS WATER ENTERING SPACE BETWEEN STUCCO AND CONCRETE STRUCTURAL MEMBERS AND TRAVELING DOWNWARD AND LEAKING OUT...FROM SMALL CRACKS IN STUCCO.

No building structural concrete members are in need of repair at this time.  
However, the repair of the several front walkway pavers found loose/adjar, are required to be repaired.(Reference 2.c.).  
Moreover, stucco repair patch work at cracks, in order to maintain water-proofing function, is recommended.

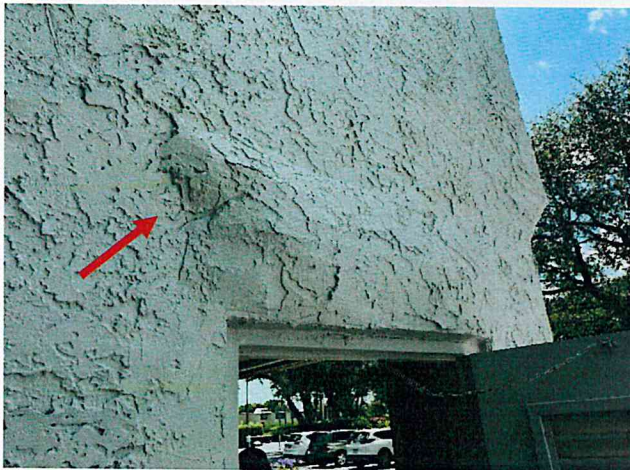
At building trash-bin closet, at pedestrian door, header shows noticable delamination of patched stucco. Reference back to 2.c. for photo.

STUCCO AT BUILDING TRASH-BIN CLOSET, AT PEDESTRIAN DOOR HEADER, SHOWS NOTICABLE DELAMINATION OF STUCCO. OPPOSITE SIDE (NOT PICTURED) SHOWS HEADER INFILL PATCH. (DELAMINATION IS ALSO NOTED BY WHITE CHALK OUTLINING REGION IN PICTURE IMMEDIATELY ABOVE.)

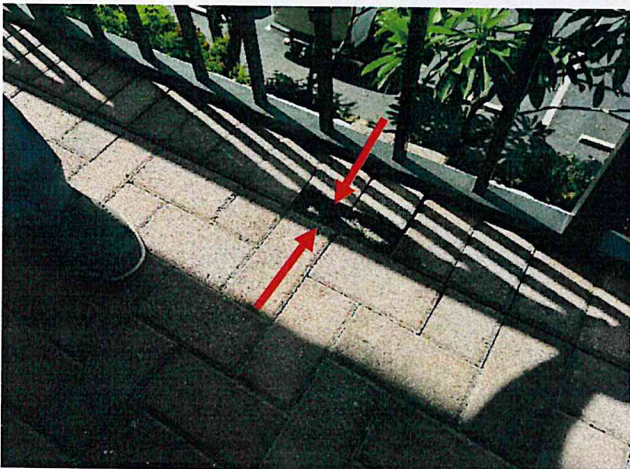
SEEN AT MULTIPLE LOCATIONS, AT FRONT WALKWAY PAVERS, A NUMBER OF DISLODGED PAVERS RESTING UPON WALKWAY SURFACE ARE NOT SECURED AND ARE AT RISK OF FALLING OFF WALKWAY TO GROUND LEVEL, AT HAZARDOUS RISK TO PEDESTRIANS BELOW.

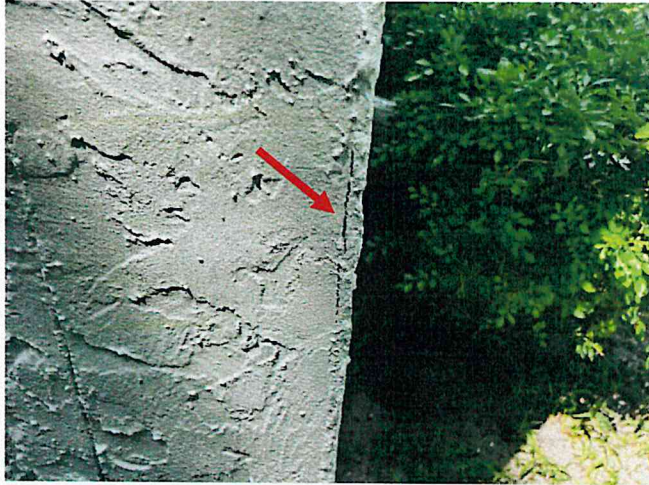
- **2-D – CRACKS:**

At some corners of the building there are Medium cracks in the stucco veneer, but these cracks are not believed to extend within the structural concrete column itself.

AT SOME CORNERS OF THE BUILDING THERE ARE MEDIUM (1 MM - 2 MM) CRACKS IN THE STUCCO VENEER, BUT THESE CRACKS DO NOT EXTEND WITHIN THE STRUCTURAL CONCRETE COLUMN ITSELF.

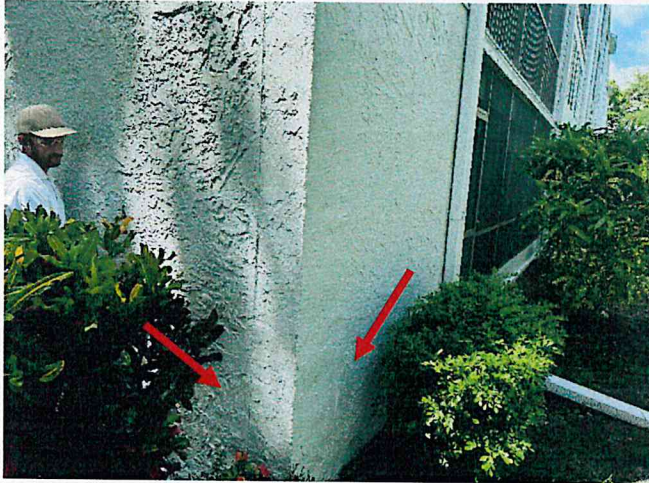
- **5-D – CRACKS THAT SIGNAL DIFFERENTIAL SETTLEMENT:**

NO INDICATIONS OF DIFFERENTIAL SETTLEMENT WERE OBSERVED.

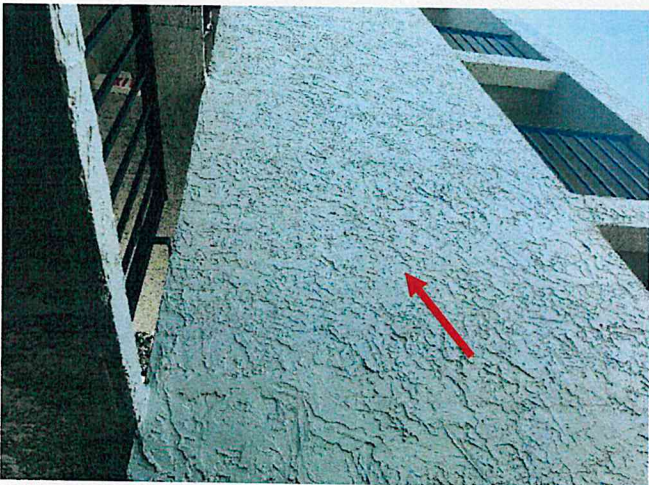
- **6-A – CONCRETE UNITS:**

CONCRETE MASONRY UNITS ARE USED TO INFILL STAIRWELL WALLS. CONDITION IS NOTED AS: GOOD.

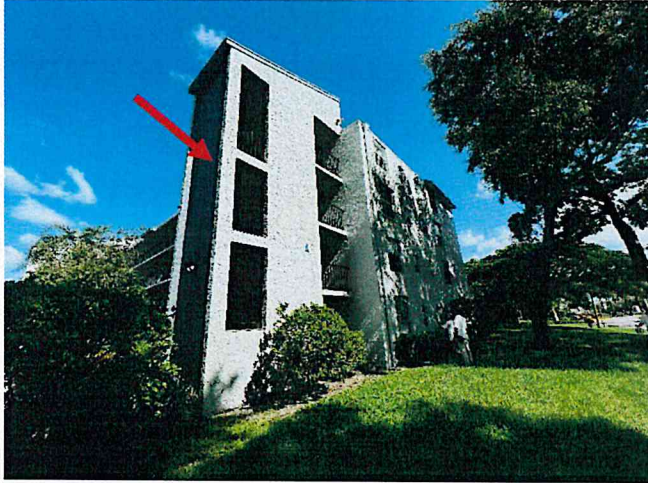
- **6-C REINFORCED CONCRETE TIE COLUMNS:**

STRUCTURAL CONCRETE TIE COLUMN'S CONDITION IS NOTED AS: GOOD.

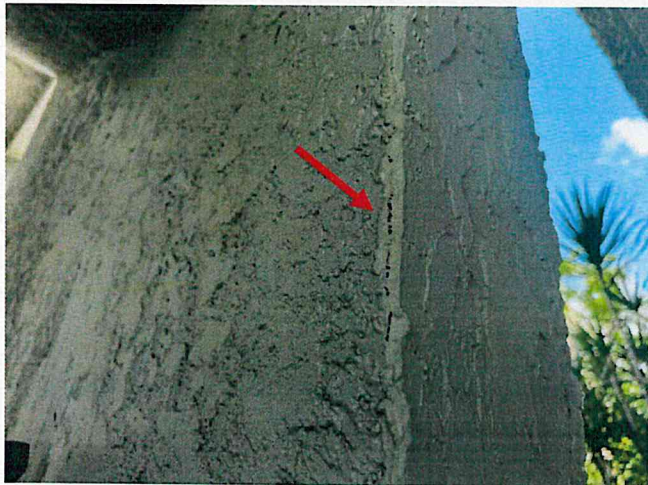
- **6-G-1 – MASONRY FINISH, STUCCO:**

Stairwell shows stucco delaminating and tear lines developing.

STAIRWELL SHOWS STUCCO DELAMINATING AND TEAR LINES DEVELOPING.

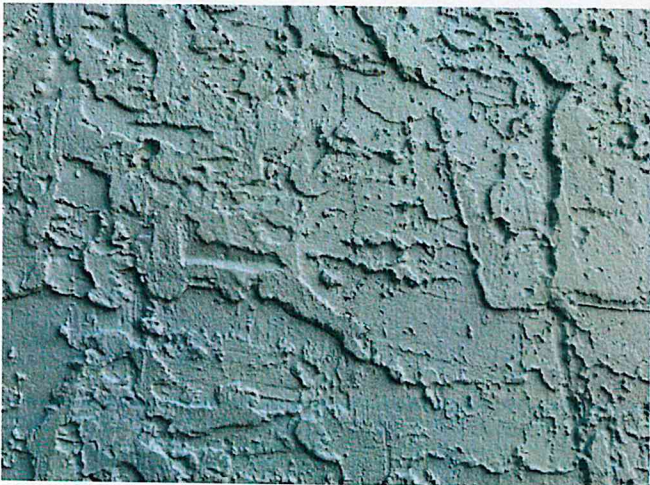
- **6-G-3 – PAINT ONLY:**

PAINT ON STUCCO IS IN GOOD CONDITION.

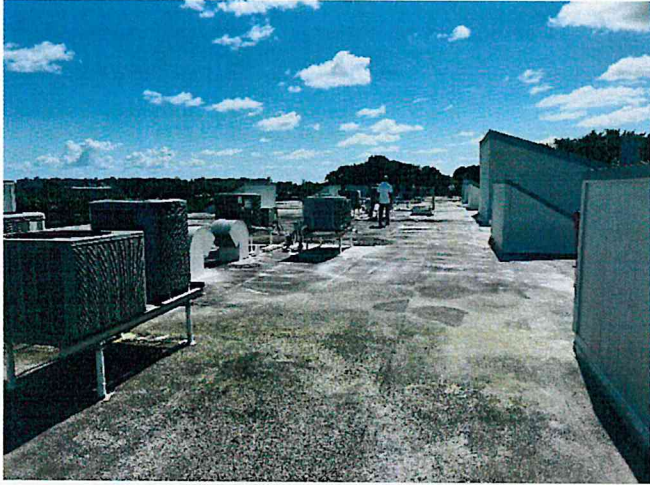
**ROOF IS A FLAT-ROOF STYLE OVERALL.**

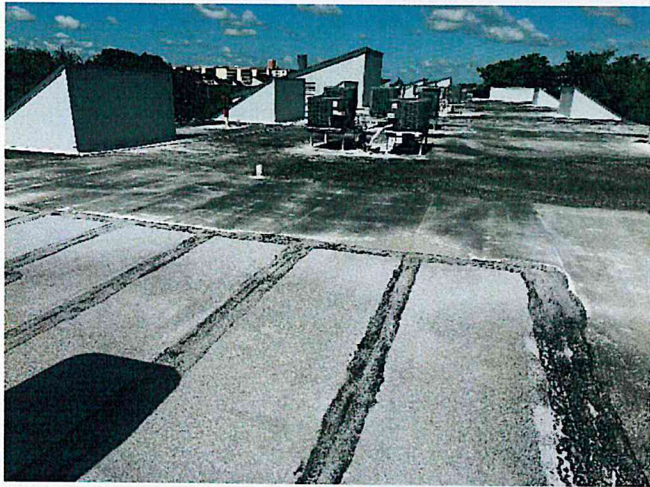
**ROOF IS A COMBINATION OF BUILT-UP ROOF & TPO  
ROOF ASSEMBLY TYPES.**

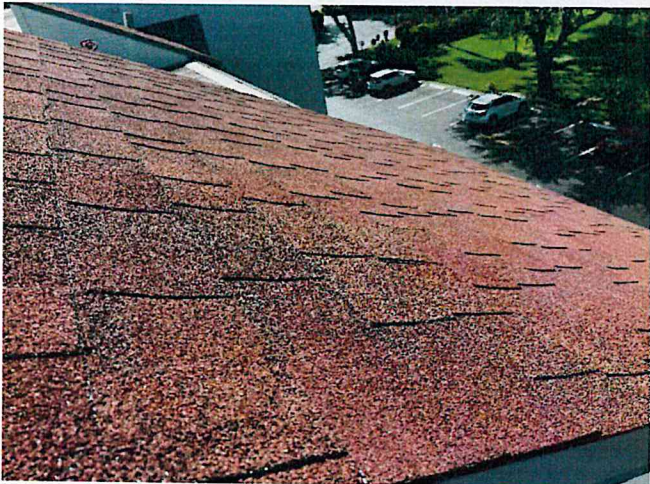
**ROOF HAS MANSARD ARCHITECTURAL FEATURES.**

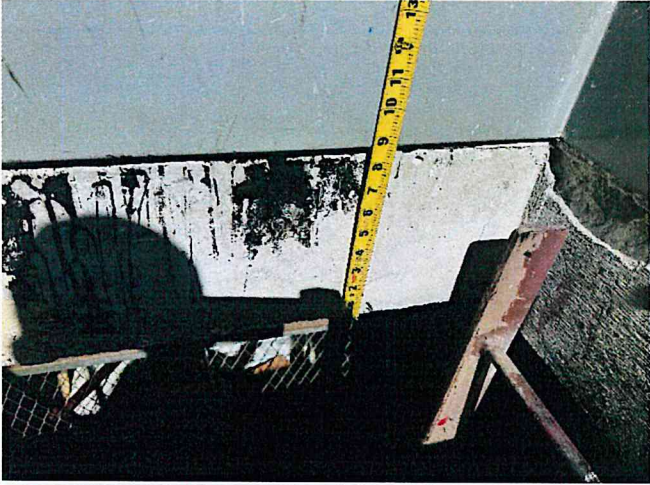
ROOF DECK IS STRUCTURAL CONCRETE DECK.

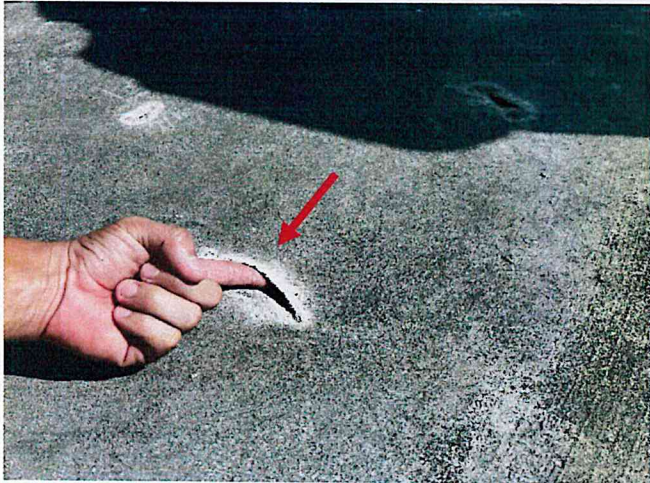
ROOF TPO MEMBRANE HAS A NUMBER OF TEARS IN A SMALL REGION.

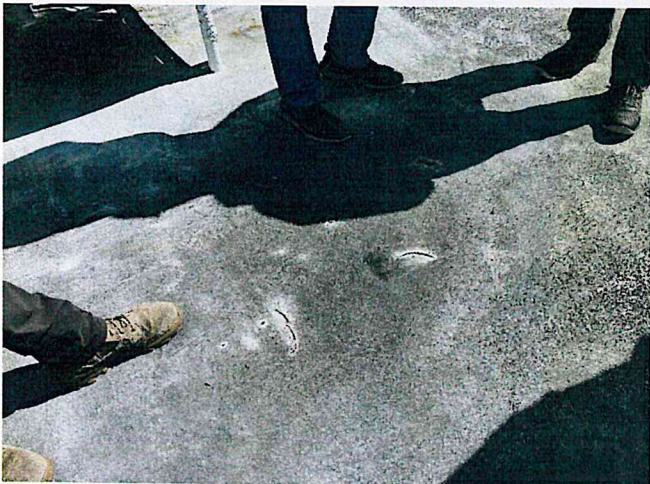
ROOF TPO MEMBRANE HAS A NUMBER OF TEARS IN A SMALL REGION. REGION PICTURED.

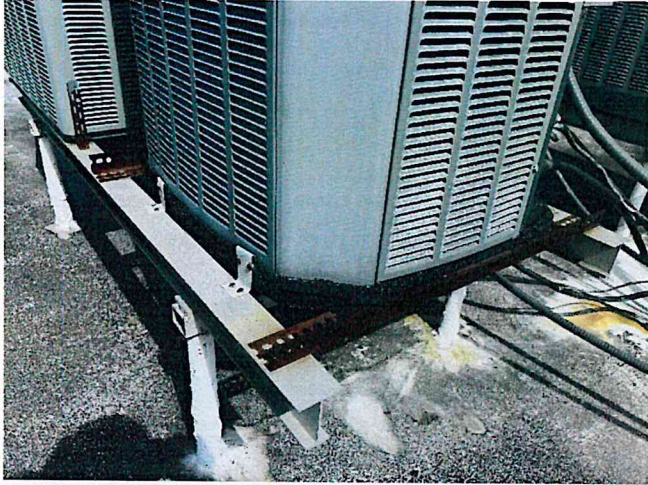
- **7-A-2 – ROOF EQUIPMENT:**

Where ever affected by oxidation, the rooftop A/C unit's straps and L-angle supports need replacement. We observed such component locations affected by oxidation, leaving them in poor condition.

ROOFTOP A/C UNIT'S STRAPS AND L-ANGLE SUPPORTS NEED REPLACEMENT, WHERE AFFECTED BY OXIDATION.

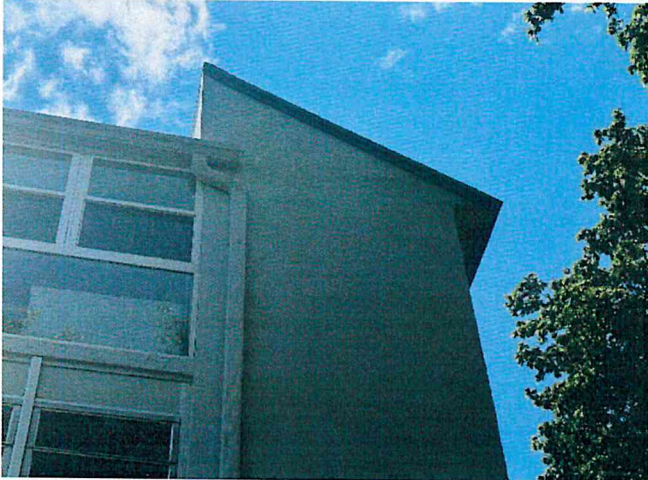
- **7-A3 – GUTTERS:**

GUTTERS ARE IN GOOD CONDITION.

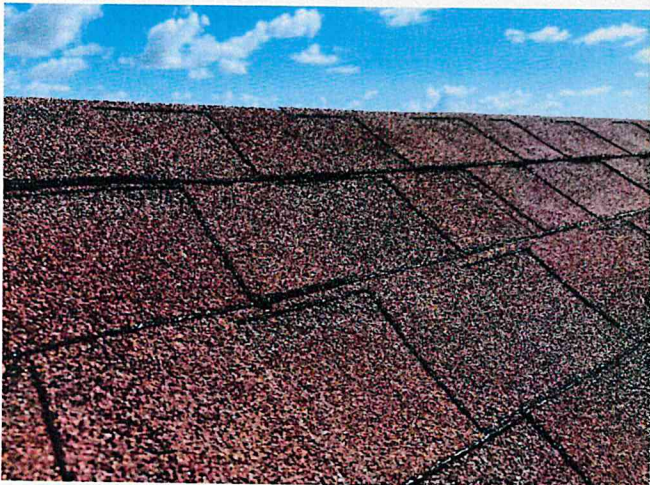
- **7-A5 – MANSARD:**

MANSARD ASPHALT SHINGLE COVERINGS ARE IN GOOD CONDITION.

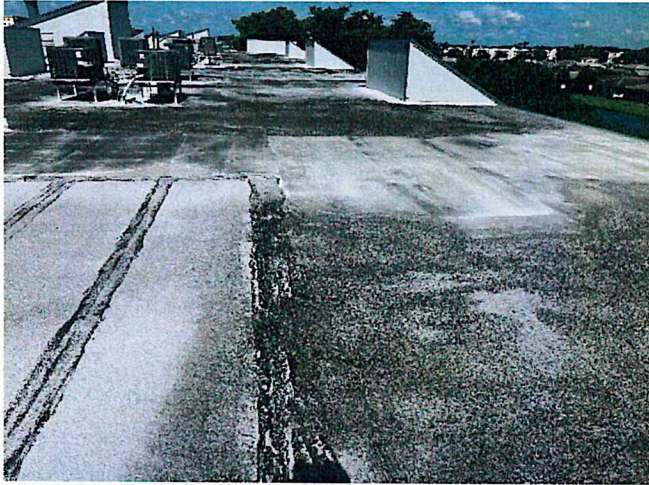
- **7-A-6 – ROOF MEMBRANE/COVERING:**

6. Describe roofing membrane/covering and current condition:  
UV radiation and repeated water evaporation regions has caused deterioration and material scaling & dry flaking.

UV RADIATION AND REPEATED WATER EVAPORATION REGIONS HAVE CAUSED DETERIORATION AND MATERIAL SCALING & DRY FLAKING.

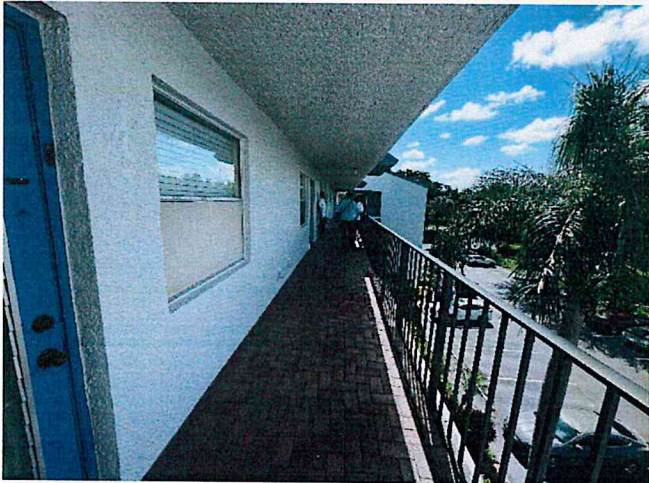
- **7-B2 – BALCONIES:**

STRUCTURAL CONCRETE CANTILEVER EXTERIOR WALKWAYS AT THE FRONT OF THE BUILDING IS IN GOOD CONDITION.

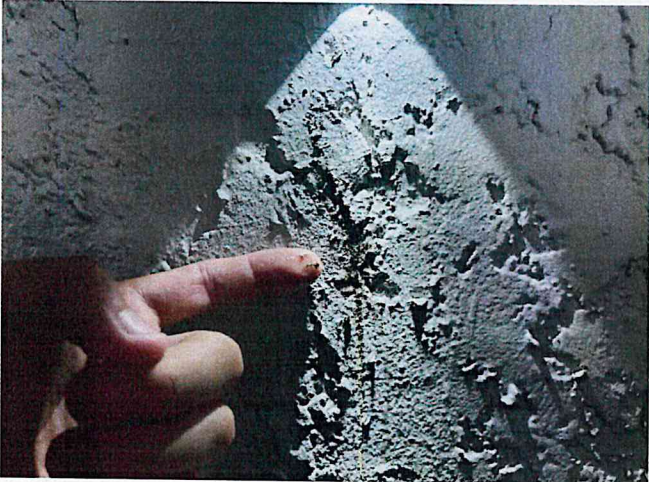
- **7-B3 – STAIRS:**

Stucco at stairwell shows signs of water penetration and leakage. Recommend preventative maintenance repairs there. Reinforced concrete framed stairs. Fair condition.

THE STUCCO AT STAIRWELL SHOWS SIGNS OF WATER PENETRATION AND LEAKAGE. RECOMMEND PREVENTATIVE MAINTENANCE REPAIRS HERE.

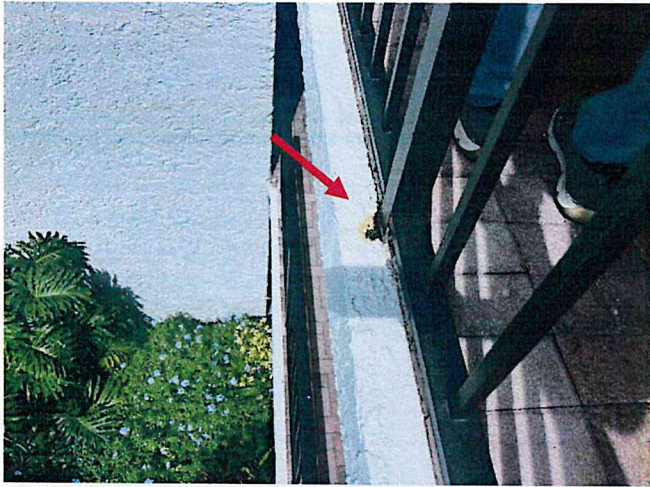
- **7-B5 – GUARDRAILS:**

Metal handrail at exterior walkways show moderate rust. A few handrail post locations are loose and in need of a repaired & fully secure embedment.

METAL HANDRAIL AT EXTERIOR WALKWAYS SHOW MODERATE RUST. A FEW HANDRAIL POST LOCATIONS ARE LOOSE AND IN NEED OF A REPAIRED & FULLY SECURE EMBEDMENT.

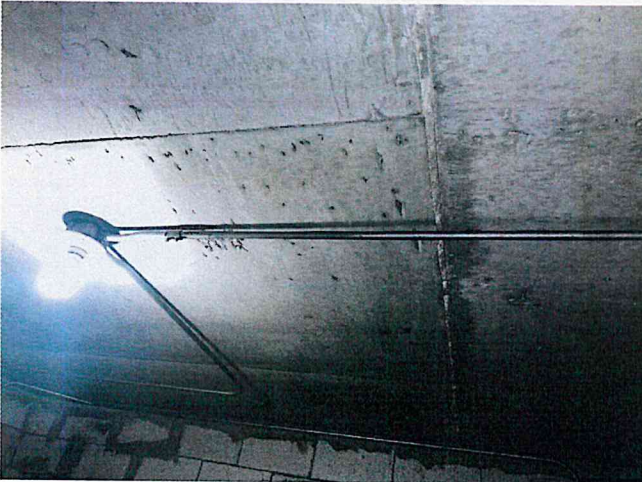
- **9-A – CONCRETE FRAMING:**

REINFORCED CONCRETE: ROOF DECK, FLOOR SLAB, COLUMNS AND FOUNDATION.

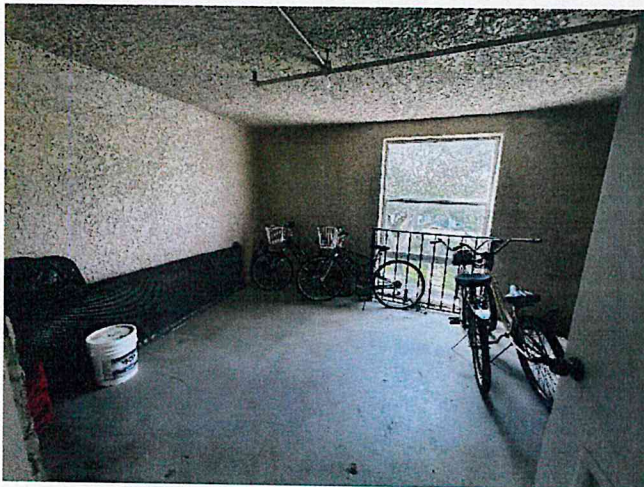
- **10-A-1 WINDOWS:**

ALUMINUM WINDOW FRAME NOTED AT STORAGE CLOSETS.

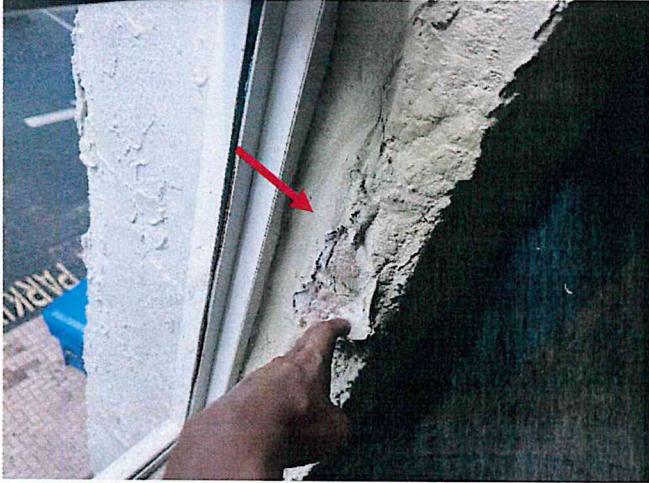
- **10-A-3 – SEALANT:**

Windows frames at storage closets (by elevator) shows deteriorated sealant & signs of water intrusion.

WINDOWS FRAMES AT STORAGE CLOSETS (BY ELEVATOR) SHOWS DETERIORATED SEALANT & SIGNS OF WATER INTRUSION.

Window frame re-seal recommended.

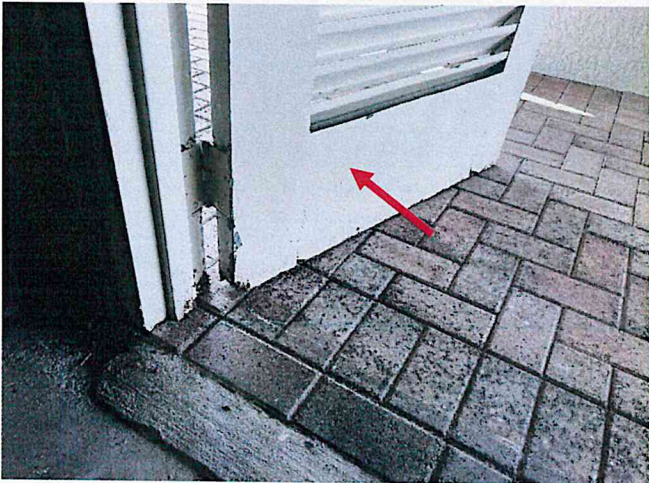
- **10-C-1 – EXTERIOR DOORS, TYPE:**

STEEL DOOR AT STORAGE & ROOF ACCESS CLOSETS.

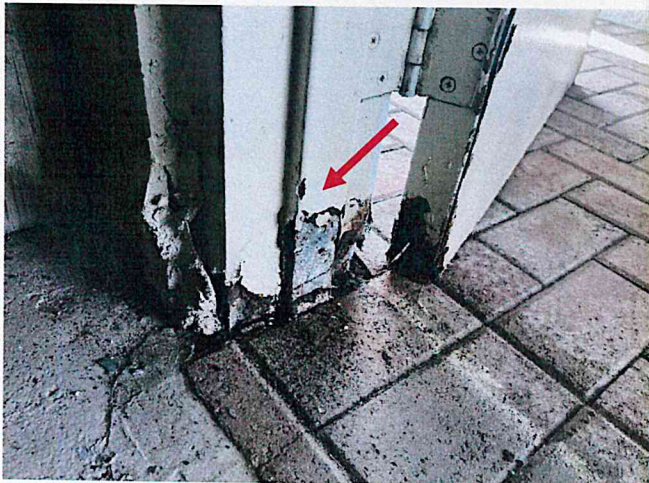
- **10-C-4 – EXTERIOR DOORS, CONDITION:**

Exterior doors' bottom corners are rusted & their door frame jambs (near floor) are rusted & deteriorated.

EXTERIOR DOORS' BOTTOM CORNERS ARE RUSTED & THEIR DOOR FRAME JAMBS (NEAR FLOOR) ARE RUSTED & DETERIORATED.

The doors remain functional. Recommend door & frame replacement at first resistance to open/closing.

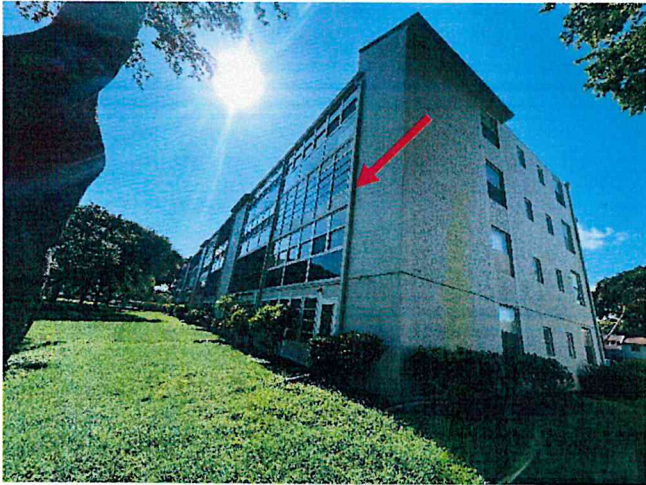
- **12-A – EXTERIOR WALL APPURTENANCES:**

STUCCO SIDING EVERYWHERE. GUTTERS WITH DOWNSPOUTS NOTED.

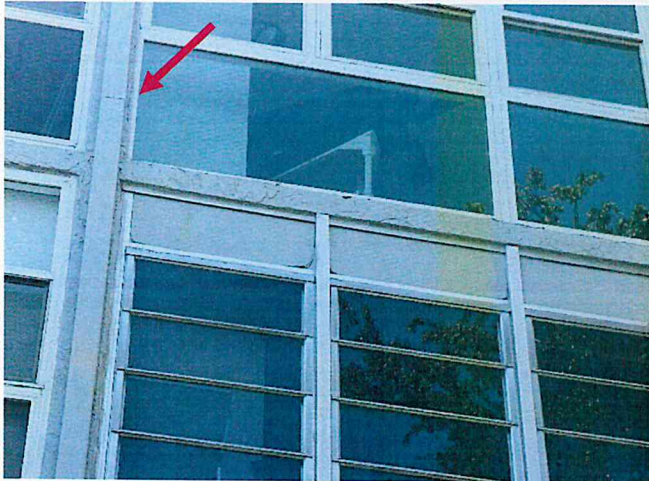
- **12-B – APPURTANANCE ATTACHMENT TYPE:**

GUTTER DOWNSPOUTS HAVE METALS STRAPS WHICH ARE SECURED TO BUILDING SIDE WITH SCREWS.

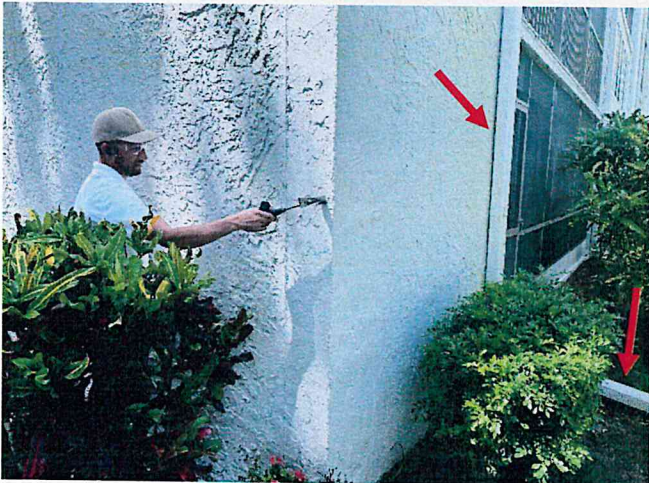
- **12-C – APPURTANANCE, CONDITION:**

GUTTER DOWN SPOUTS ARE IN GOOD CONDITION.
